Monitoring Completed Navigation Projects Program

Periodic Inspections of Cleveland Harbor East Breakwater, Ohio, and Burns Harbor North Breakwater, Indiana

May 2015

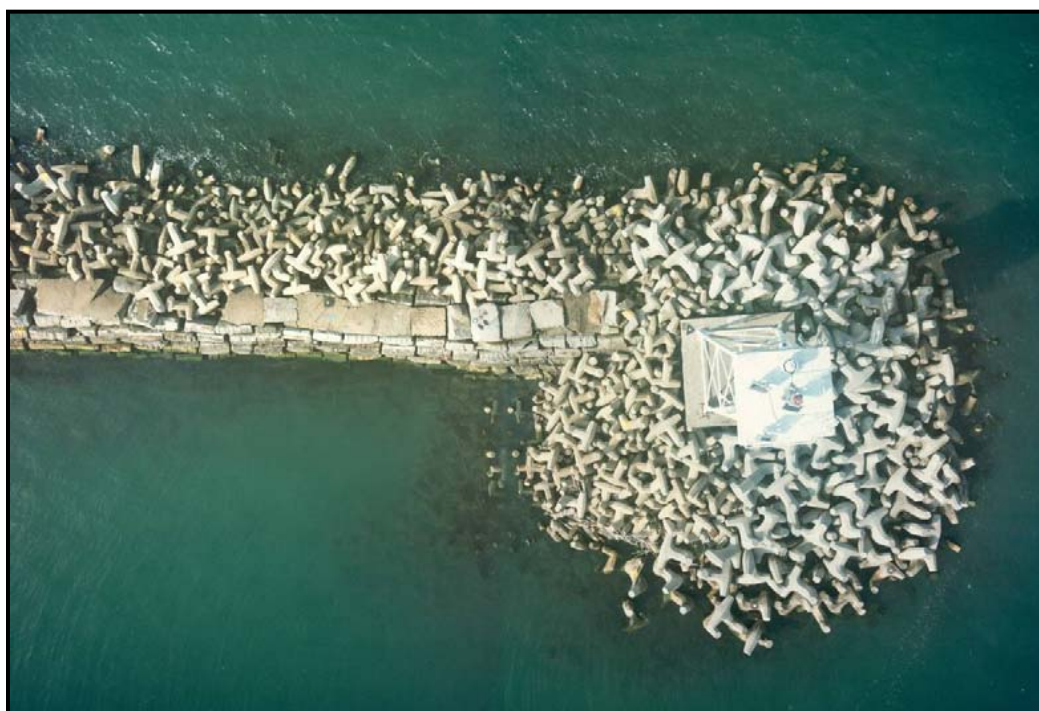
(Markle and Dubose 1985). An aerial photograph of the breakwater head (Figure 6) shows the size difference in the 2-ton and 4-ton dolosse. Other recent repairs to the East Breakwater took place in 1986, 1989, 1991, and 2001 on various sections of the westerly 16,570 ft. No dolosse were used in these areas. The harbor layout and repair/rehabilitation areas can be seen in Figure 7.

Figure 6. Aerial photograph of Cleveland Harbor East Breakwater head. Note the 4-ton dolosse used in 1987 repairs.

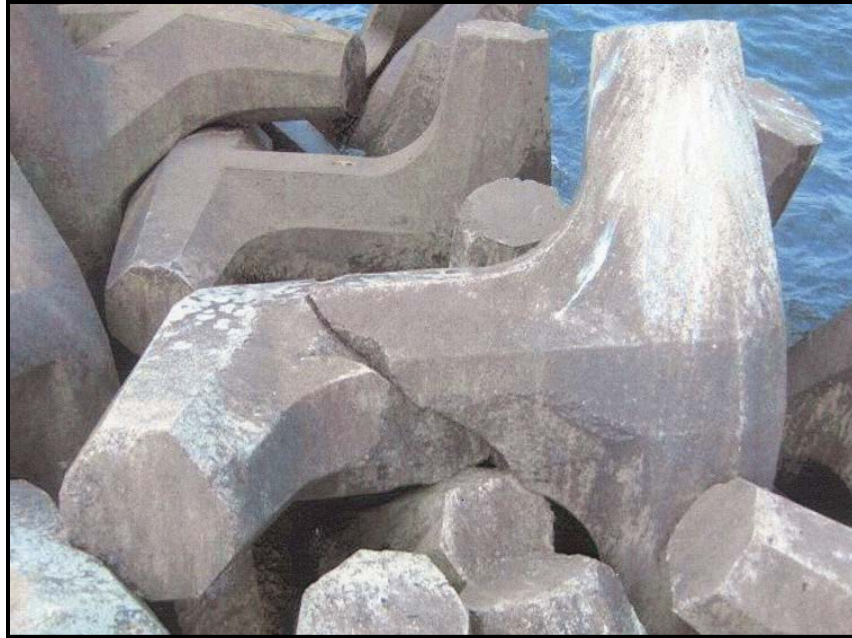
Figure 14. Example of a dolos angled midshank break.

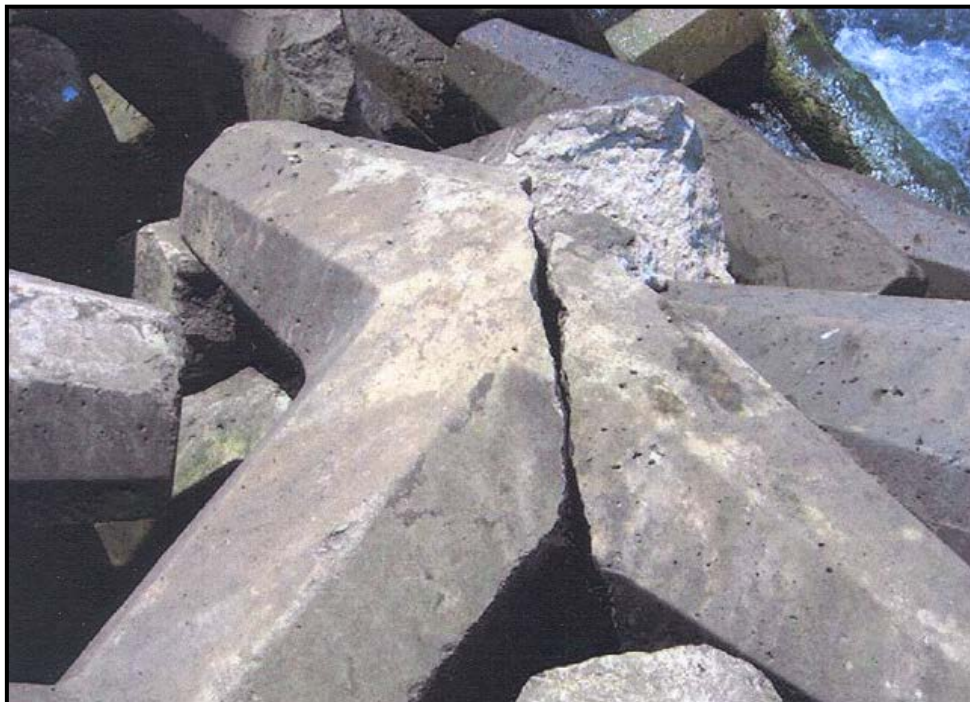
Figure 15. Example of a dolos angled fluke-shank break.

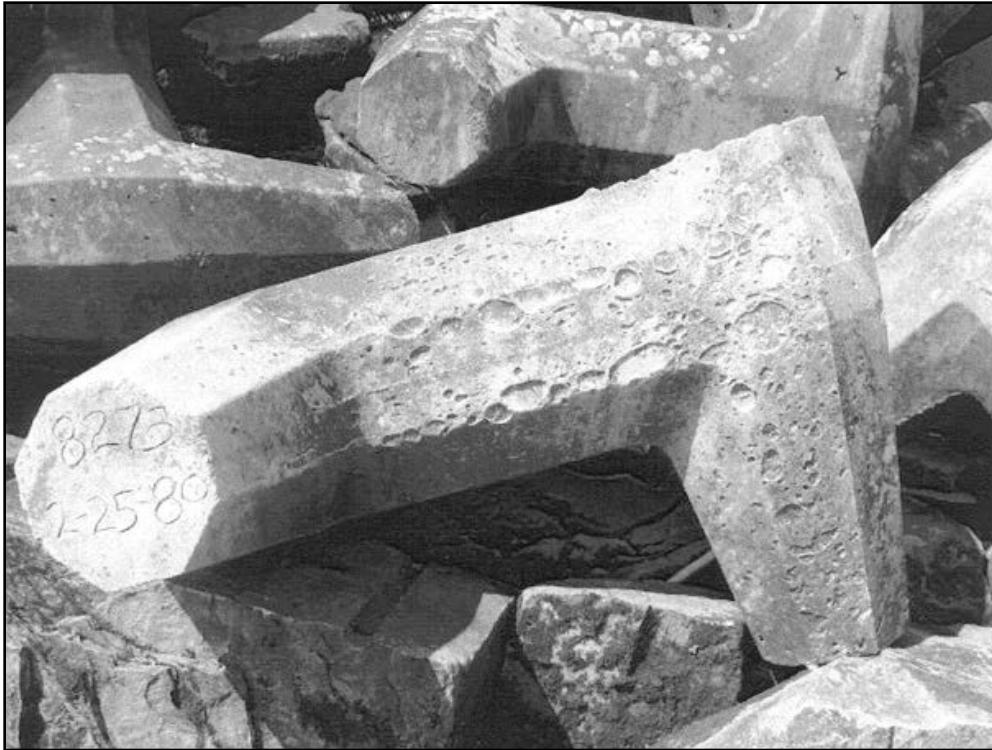
Figure 16. Example of a dolos straight fluke-shank break.

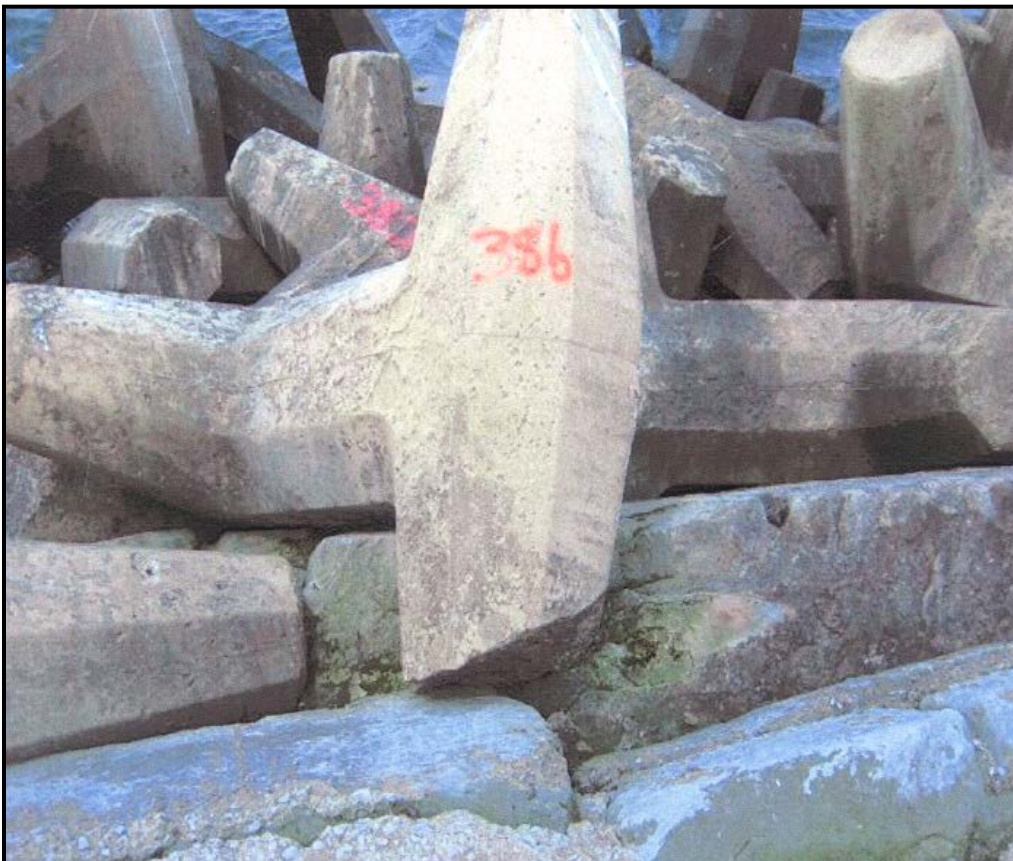
Figure 17. Example of a dolos broken fluke tip.

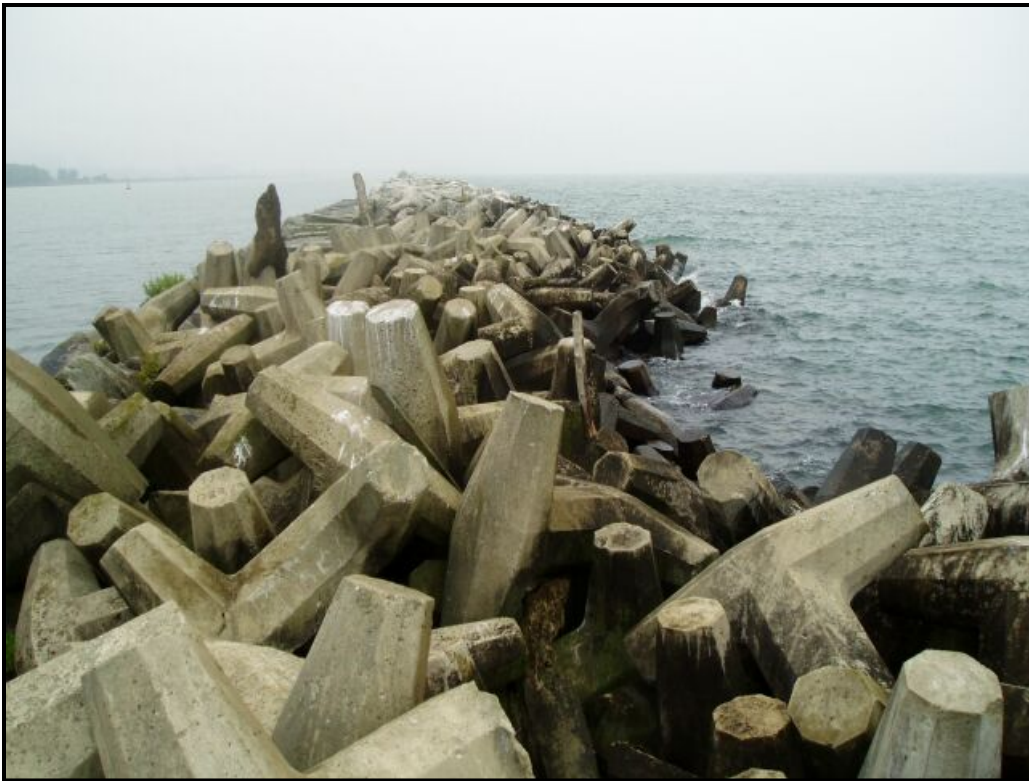
Figure 21. Example of void on lake side of Cleveland Harbor East Breakwater between sta. 230+40 and sta. 230+70, 2004 walking inspection.

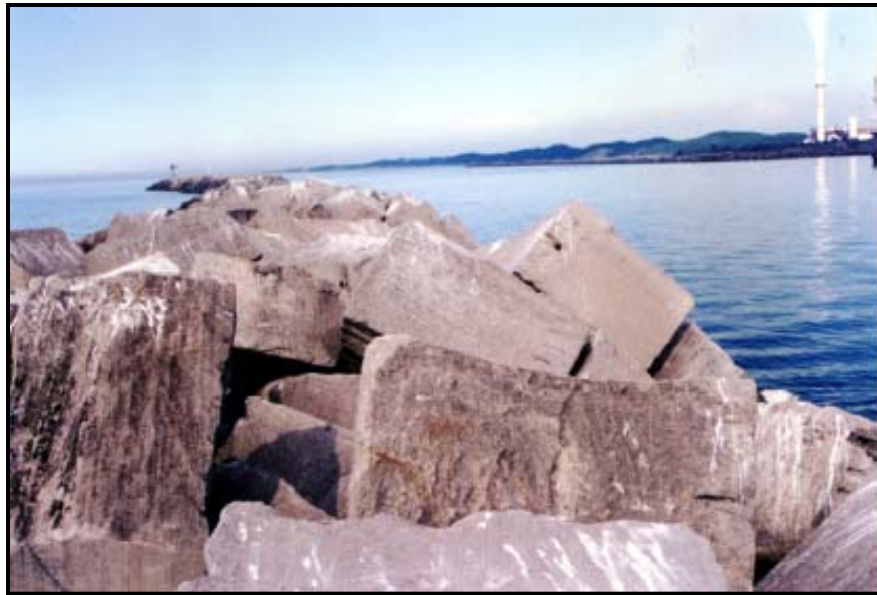
Figure 24. Burns Harbor North Breakwater, August 1999 walking inspection, looking east.

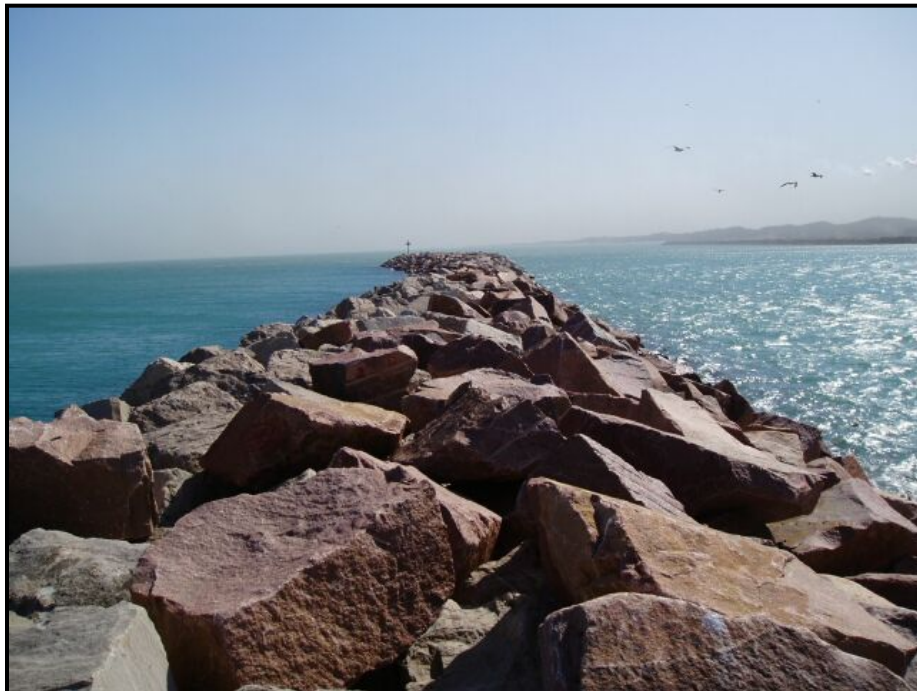
Figure 25. Burns Harbor North Breakwater, April 2004 walking inspection after repairs, looking east.

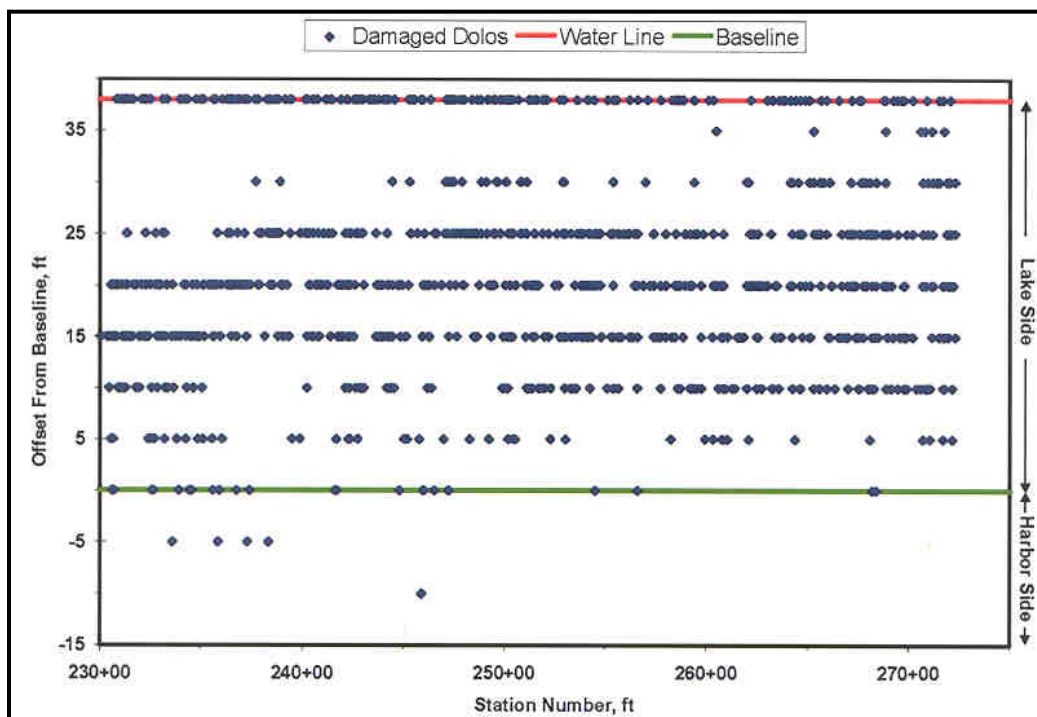
Of the 1,128 broken/cracked dolosse, 32 were from around the head with the remaining 1,096 along the trunk of the East Breakwater dolos section, and almost all were on the lake side. A distribution chart can be seen in Figure 28. Station numbers were measured with a tape for accuracy, often relying on older station marks for validation.

Figure 28. Distribution of damaged dolos armor units along Cleveland Harbor East Breakwater relative to station number, July 2006 detailed walking inspection.

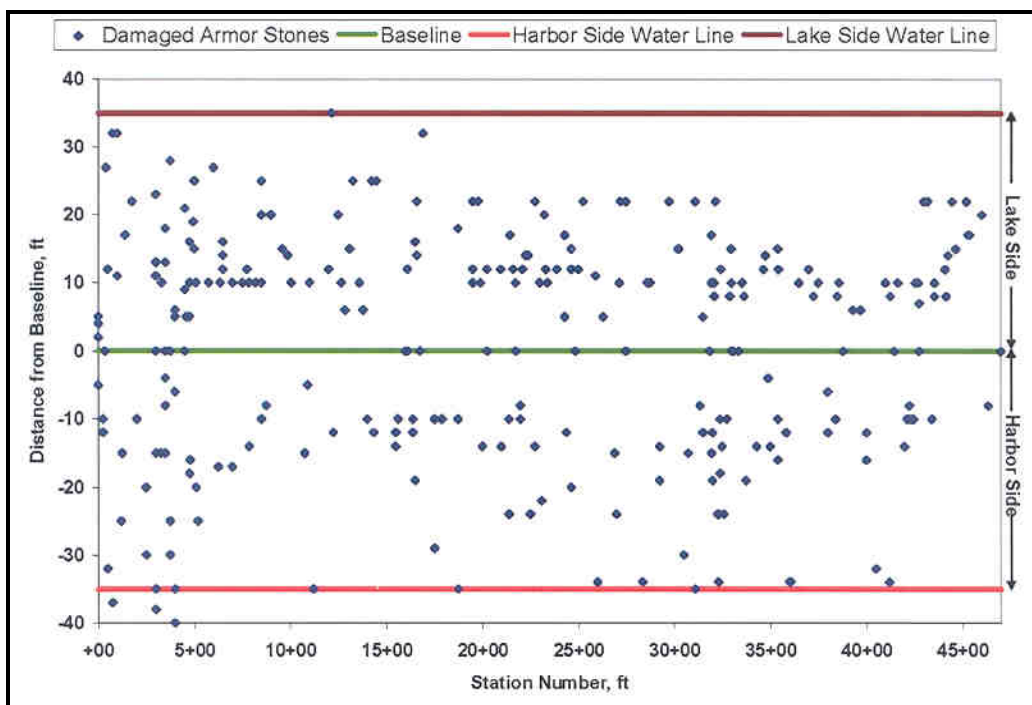
Figure 32. Distribution of damaged stone armor units along Burns Harbor North Breakwater relative to station number, August 2006 detailed walking inspection.

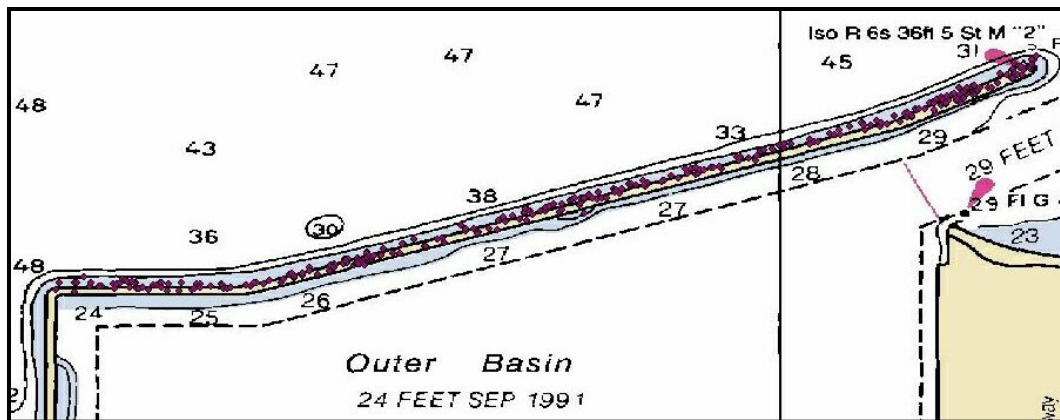
Figure 33. Locations of broken armor stones along Burns Harbor North Breakwater, August 2006 detailed walking inspection.

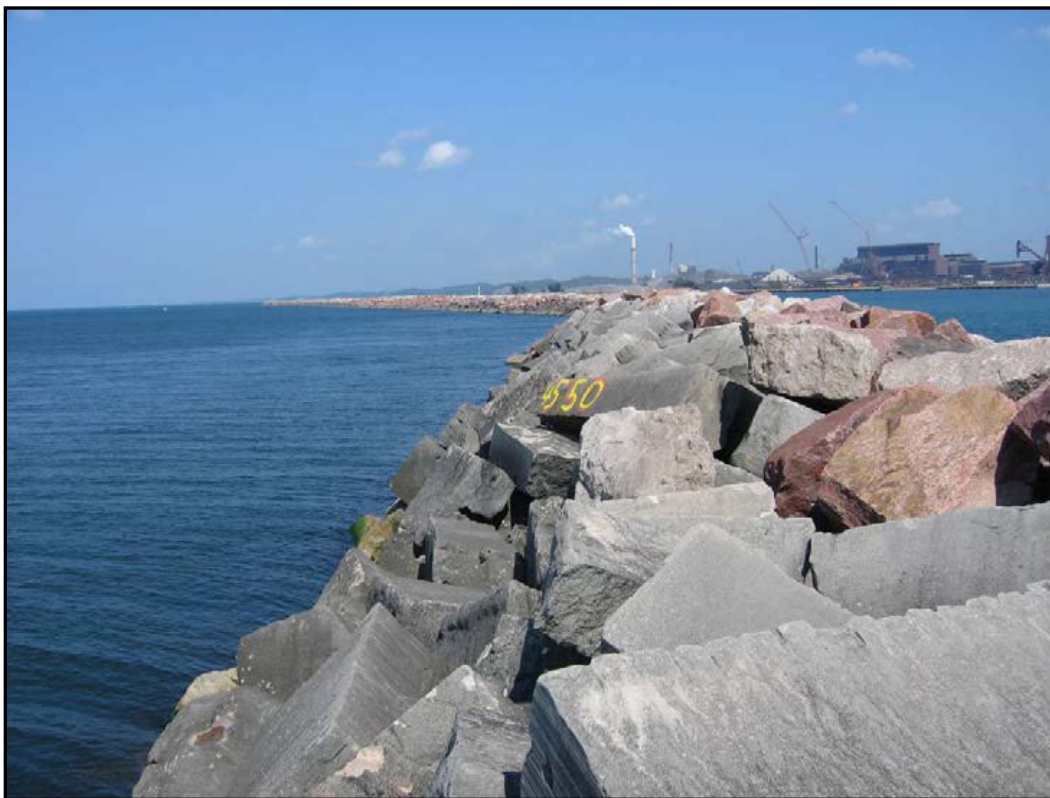
Figure 34. Burns Harbor North Breakwater looking east, August 2006 detailed walking inspection.
